Case Study:
DePaul Riverside Apartments

Riverside Apartments - Restored to the Community

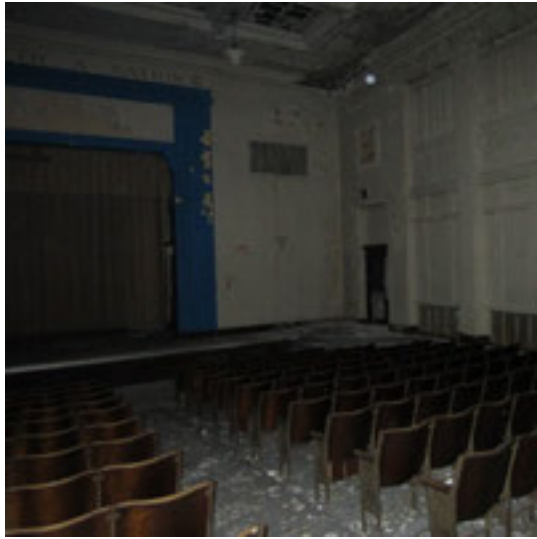
Level One (Before)

Primary
Historic Space

Secondary
Historic Space

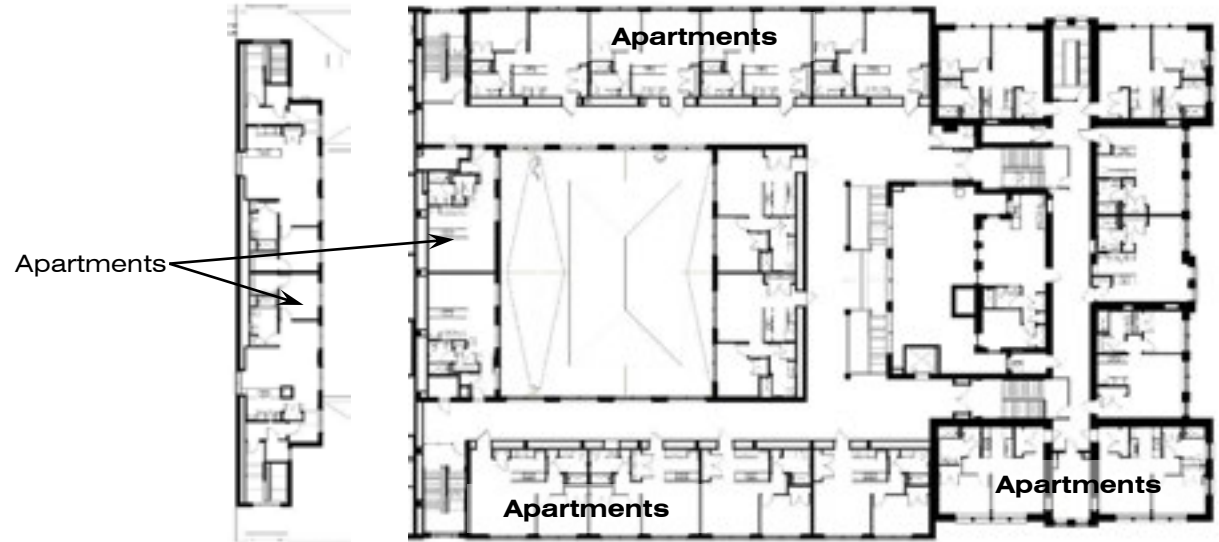
Level Four and Level Three (After)

Interior light wells provide daylight for interior facing apartments.

A small fourth floor contained locker rooms, which were repurposed into two apartments with views to the waterfront.

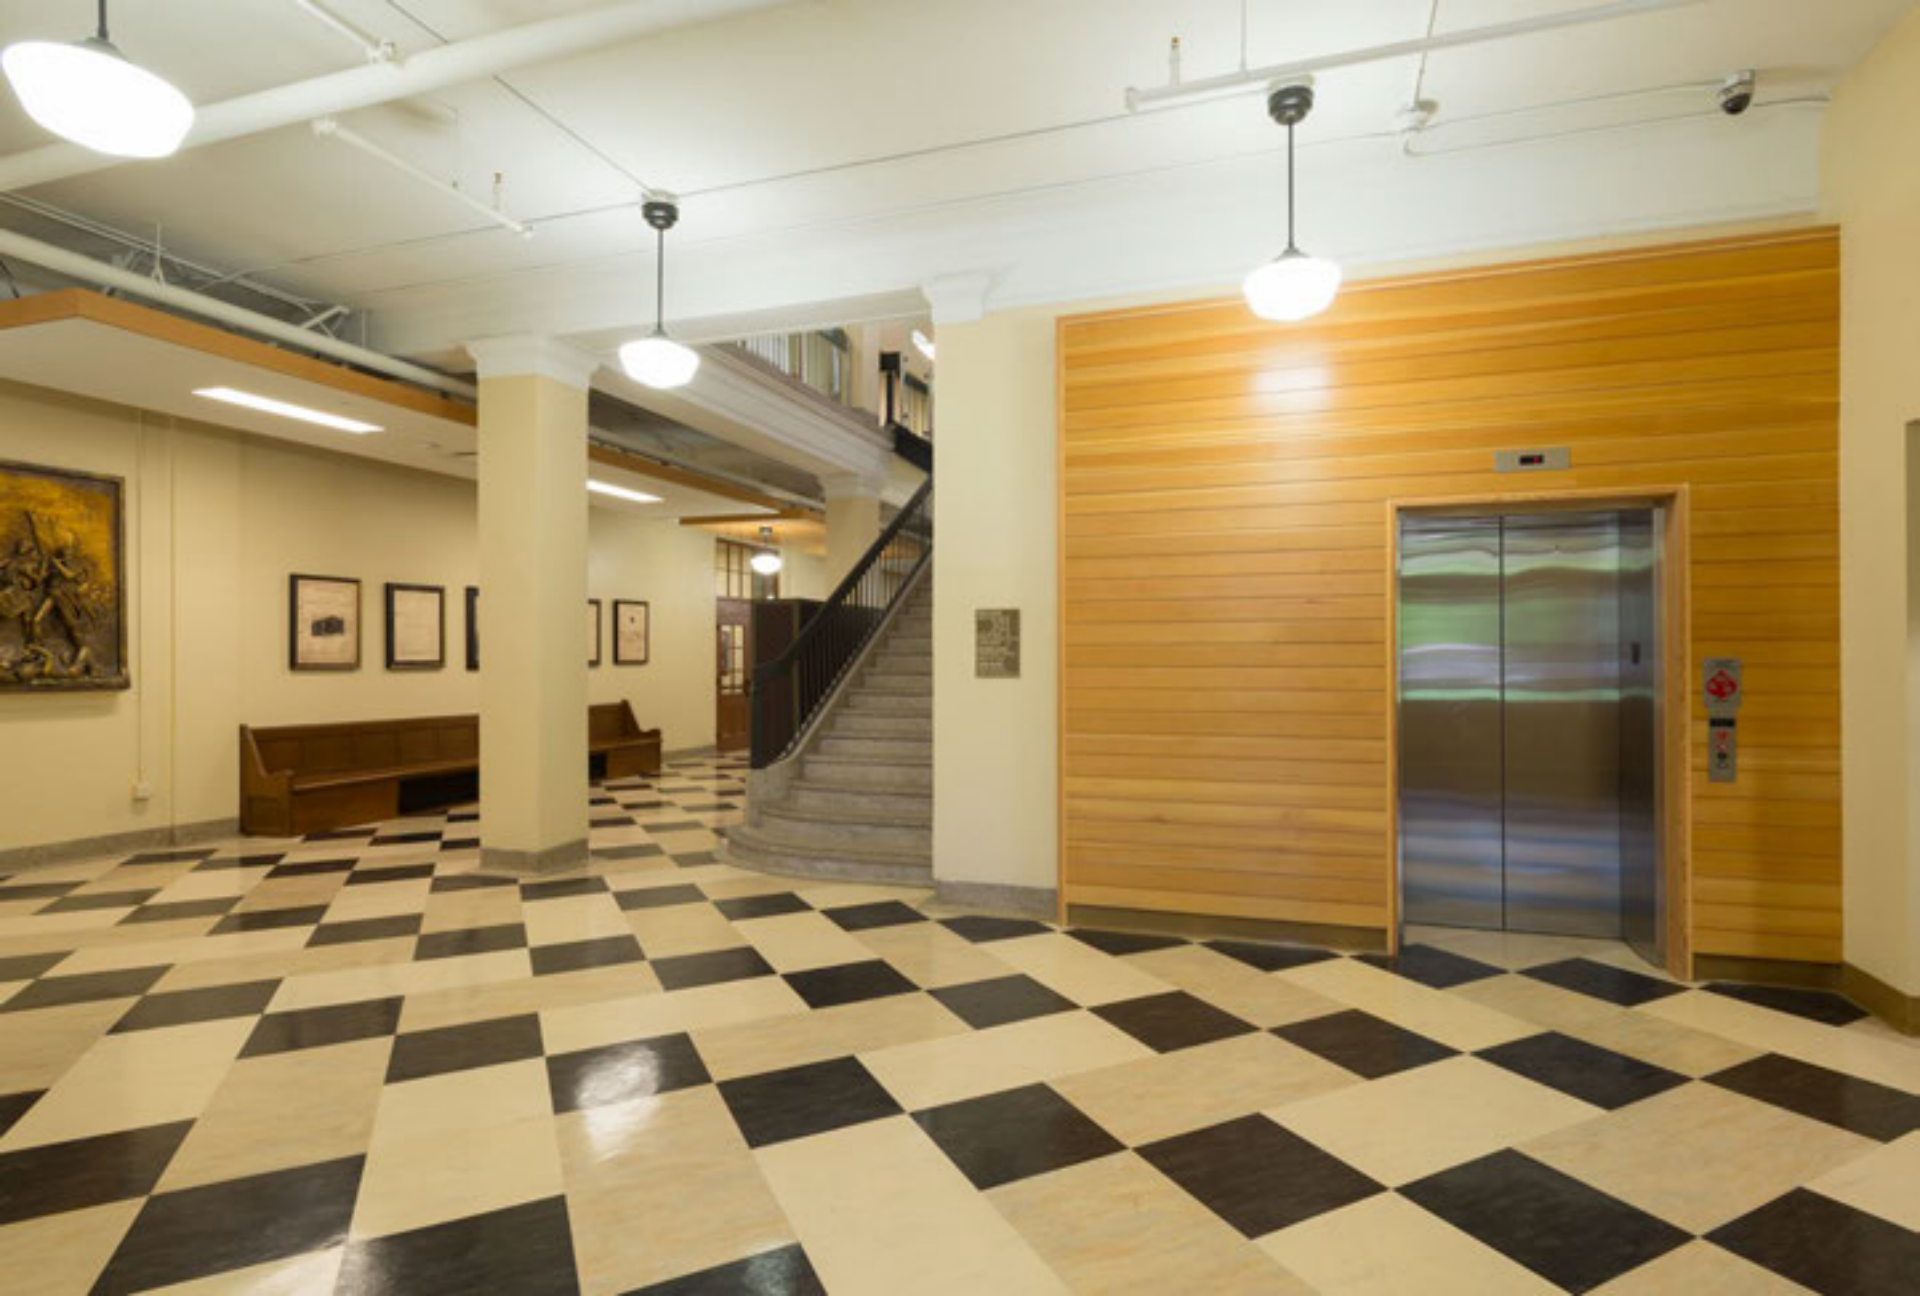
New Elevator *constructed in existing light well, elevator avoids taking up valuable floor area*

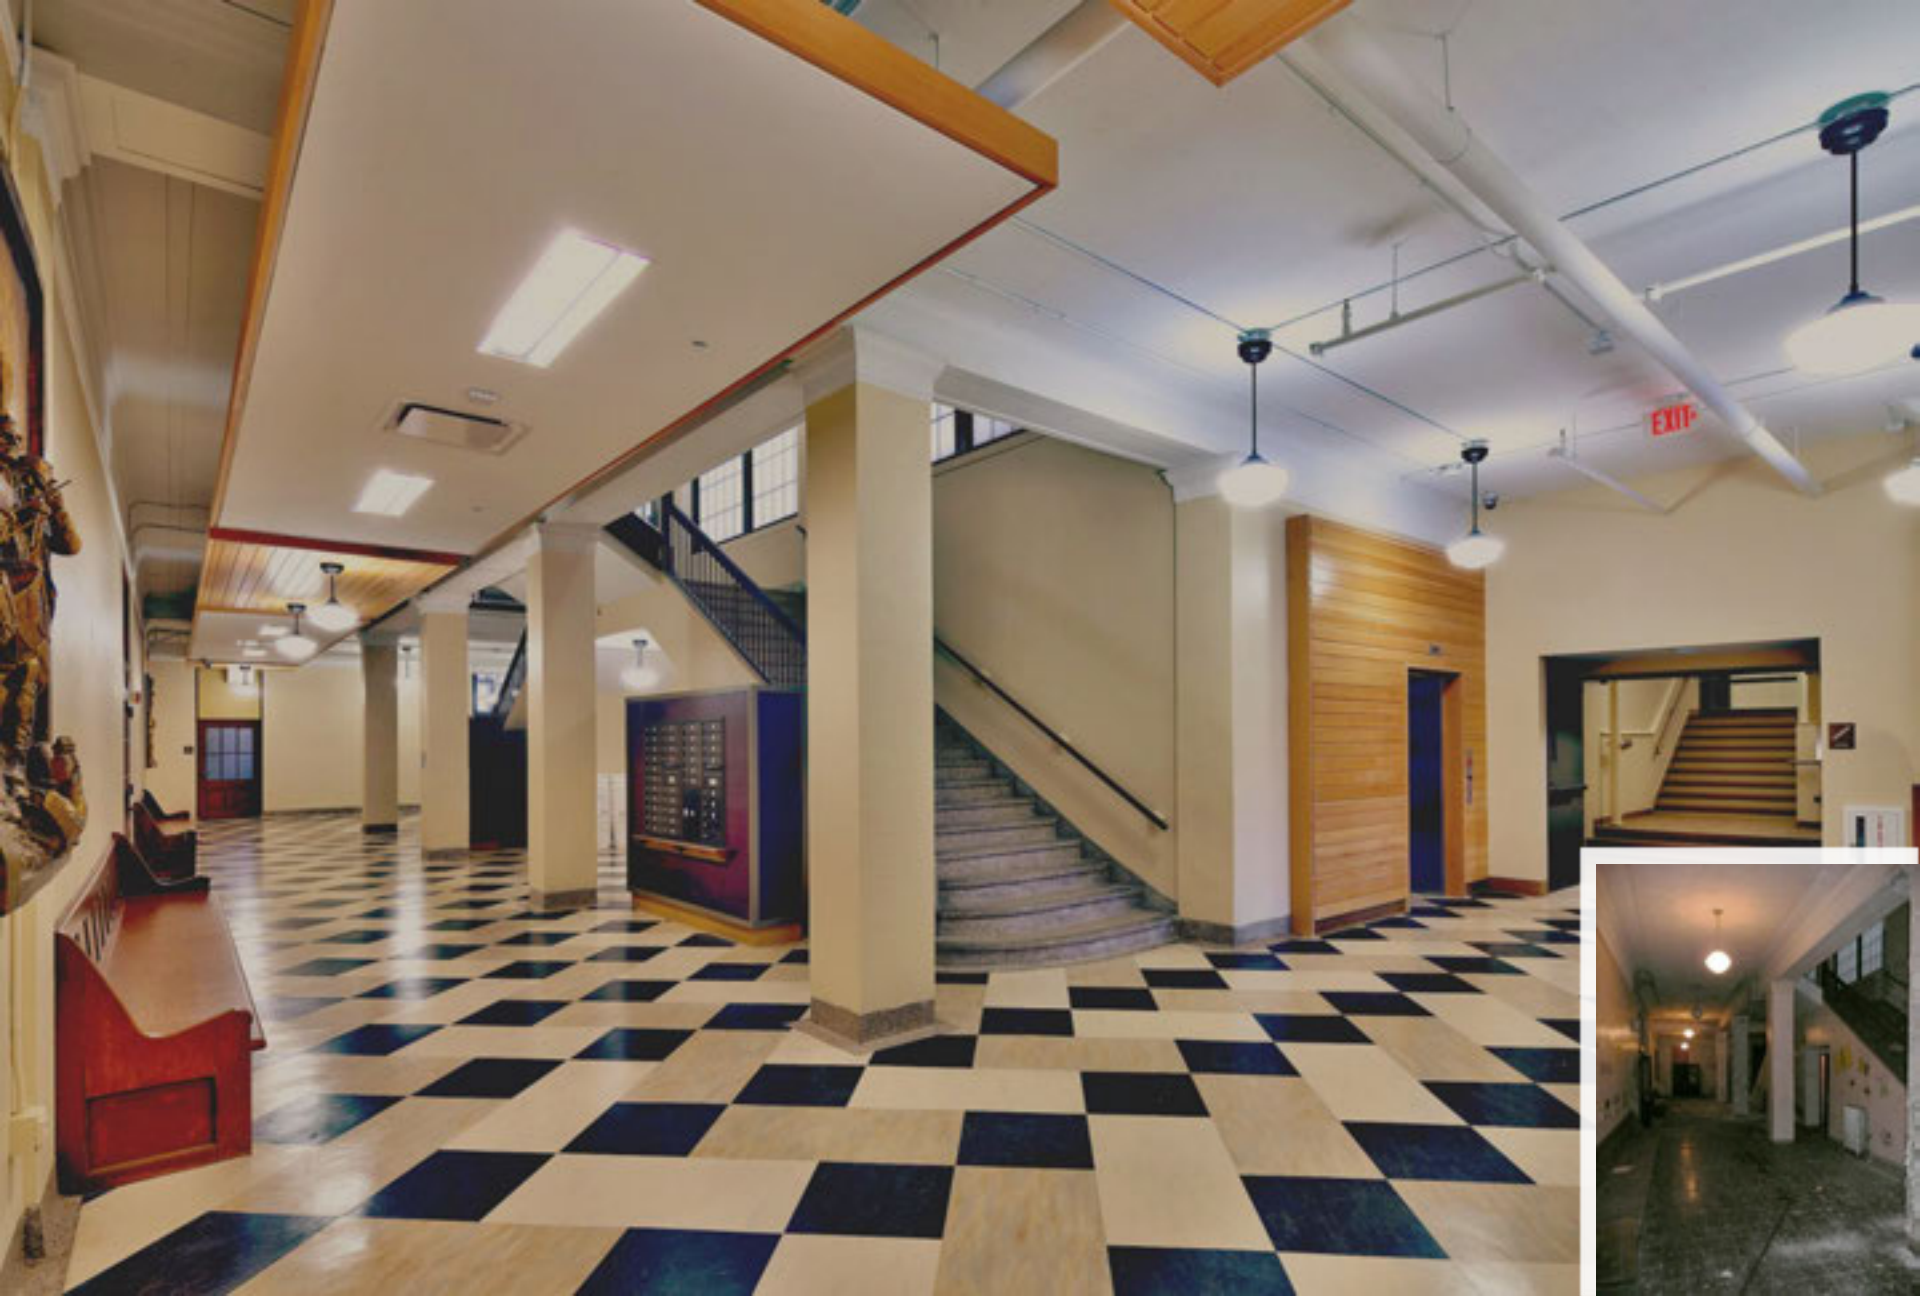
Grand Stair *slate from chalk boards has been repurposed to house tenant mailboxes*

Existing materials were reused within the building wherever possible. Classroom doors were restored for use as apartment entrances. Hardwood floors pulled from the gymnasium were refinished and used as hallway flooring. Marble shower partitions from the locker rooms were repurposed as wainscoting in the community and staff restrooms. Chalk-board surfaces were designed into enclosures to hold the new community mailboxes.

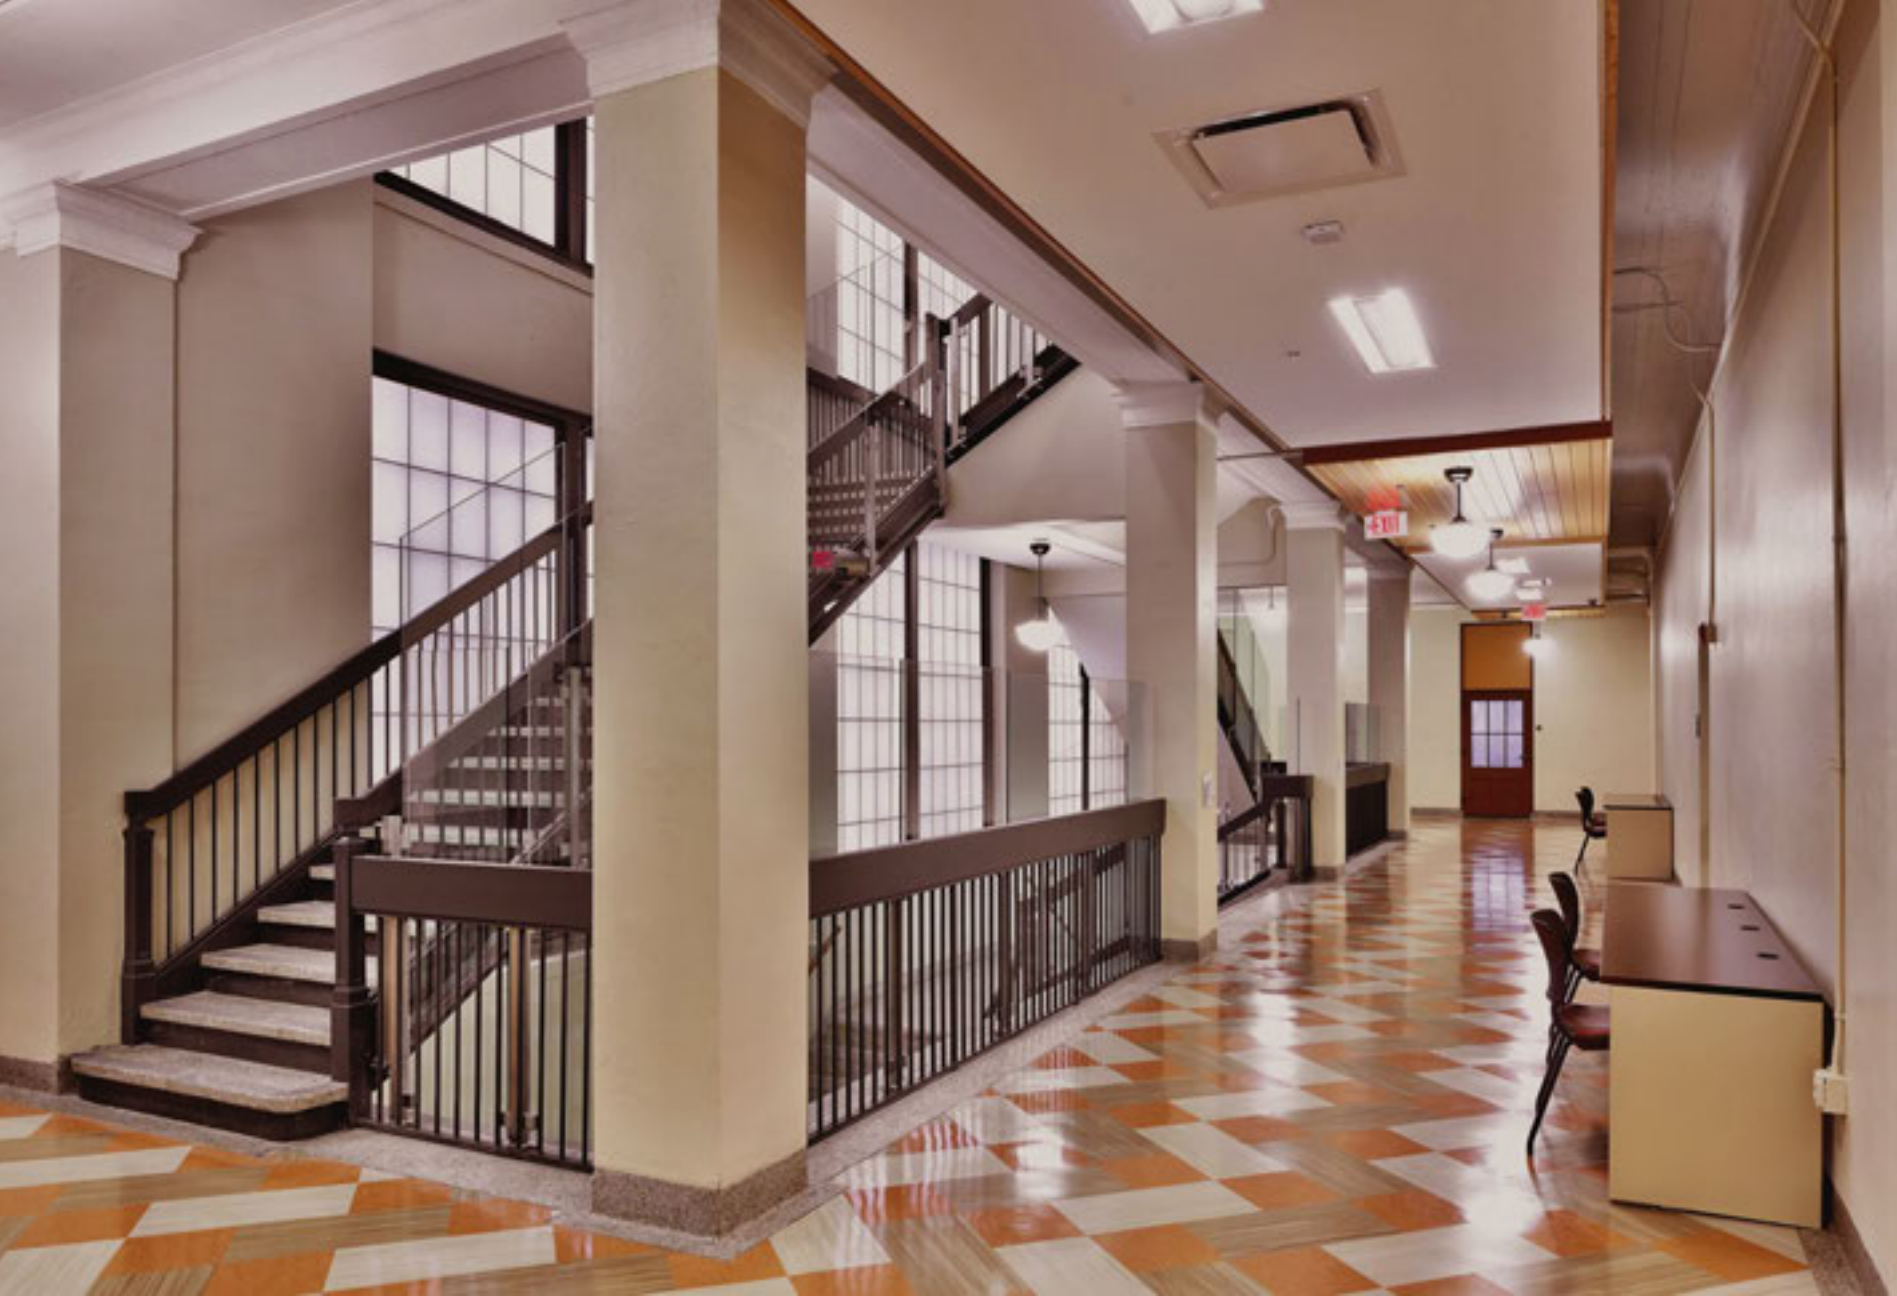
Grand Stair *glass railings provide updated safety without compromising historic appearance*

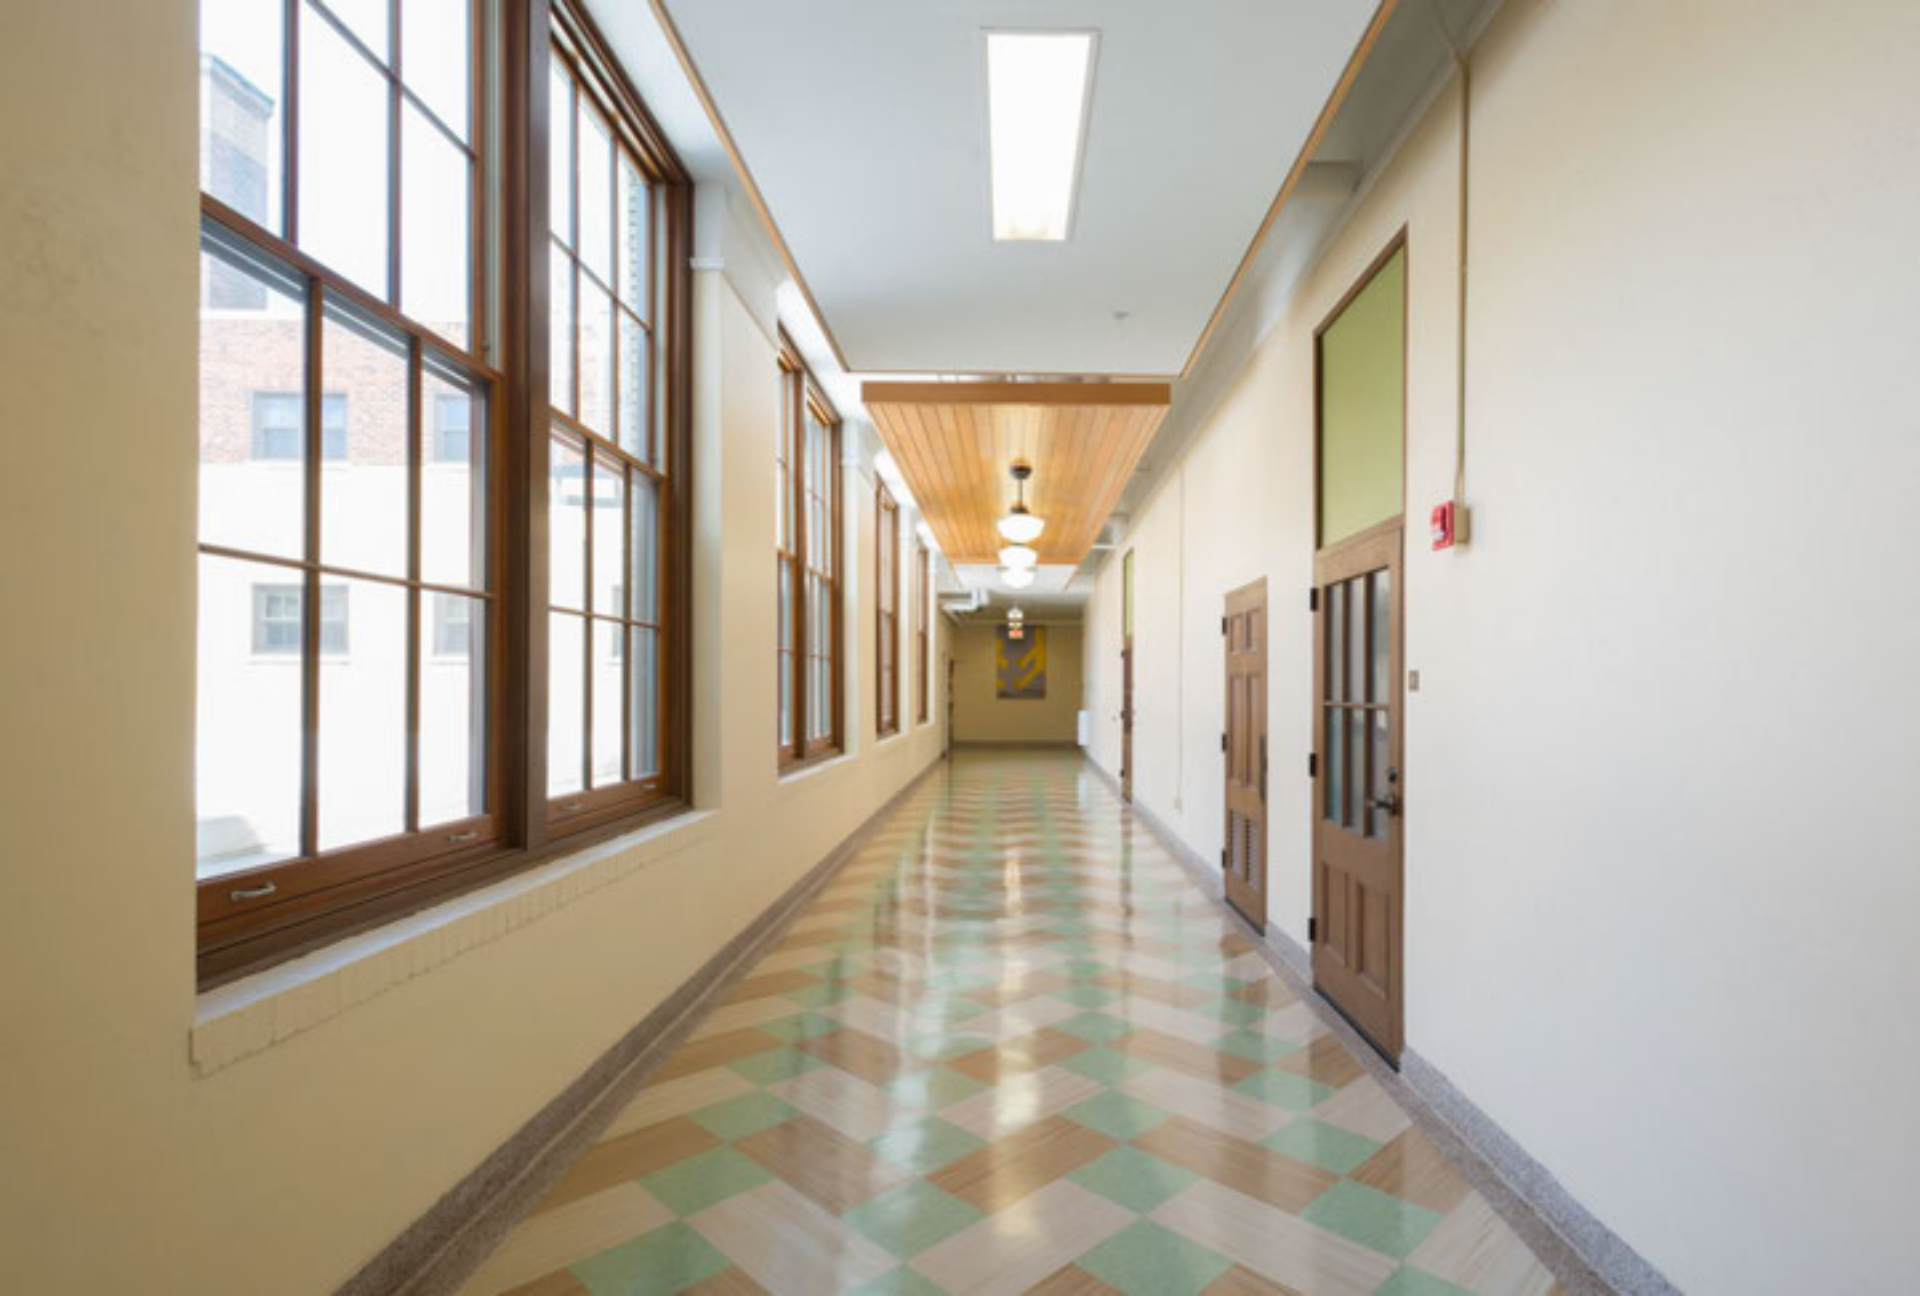
Circulation *gypsum and wood ceiling 'clouds' conceal building systems below historic ceiling*

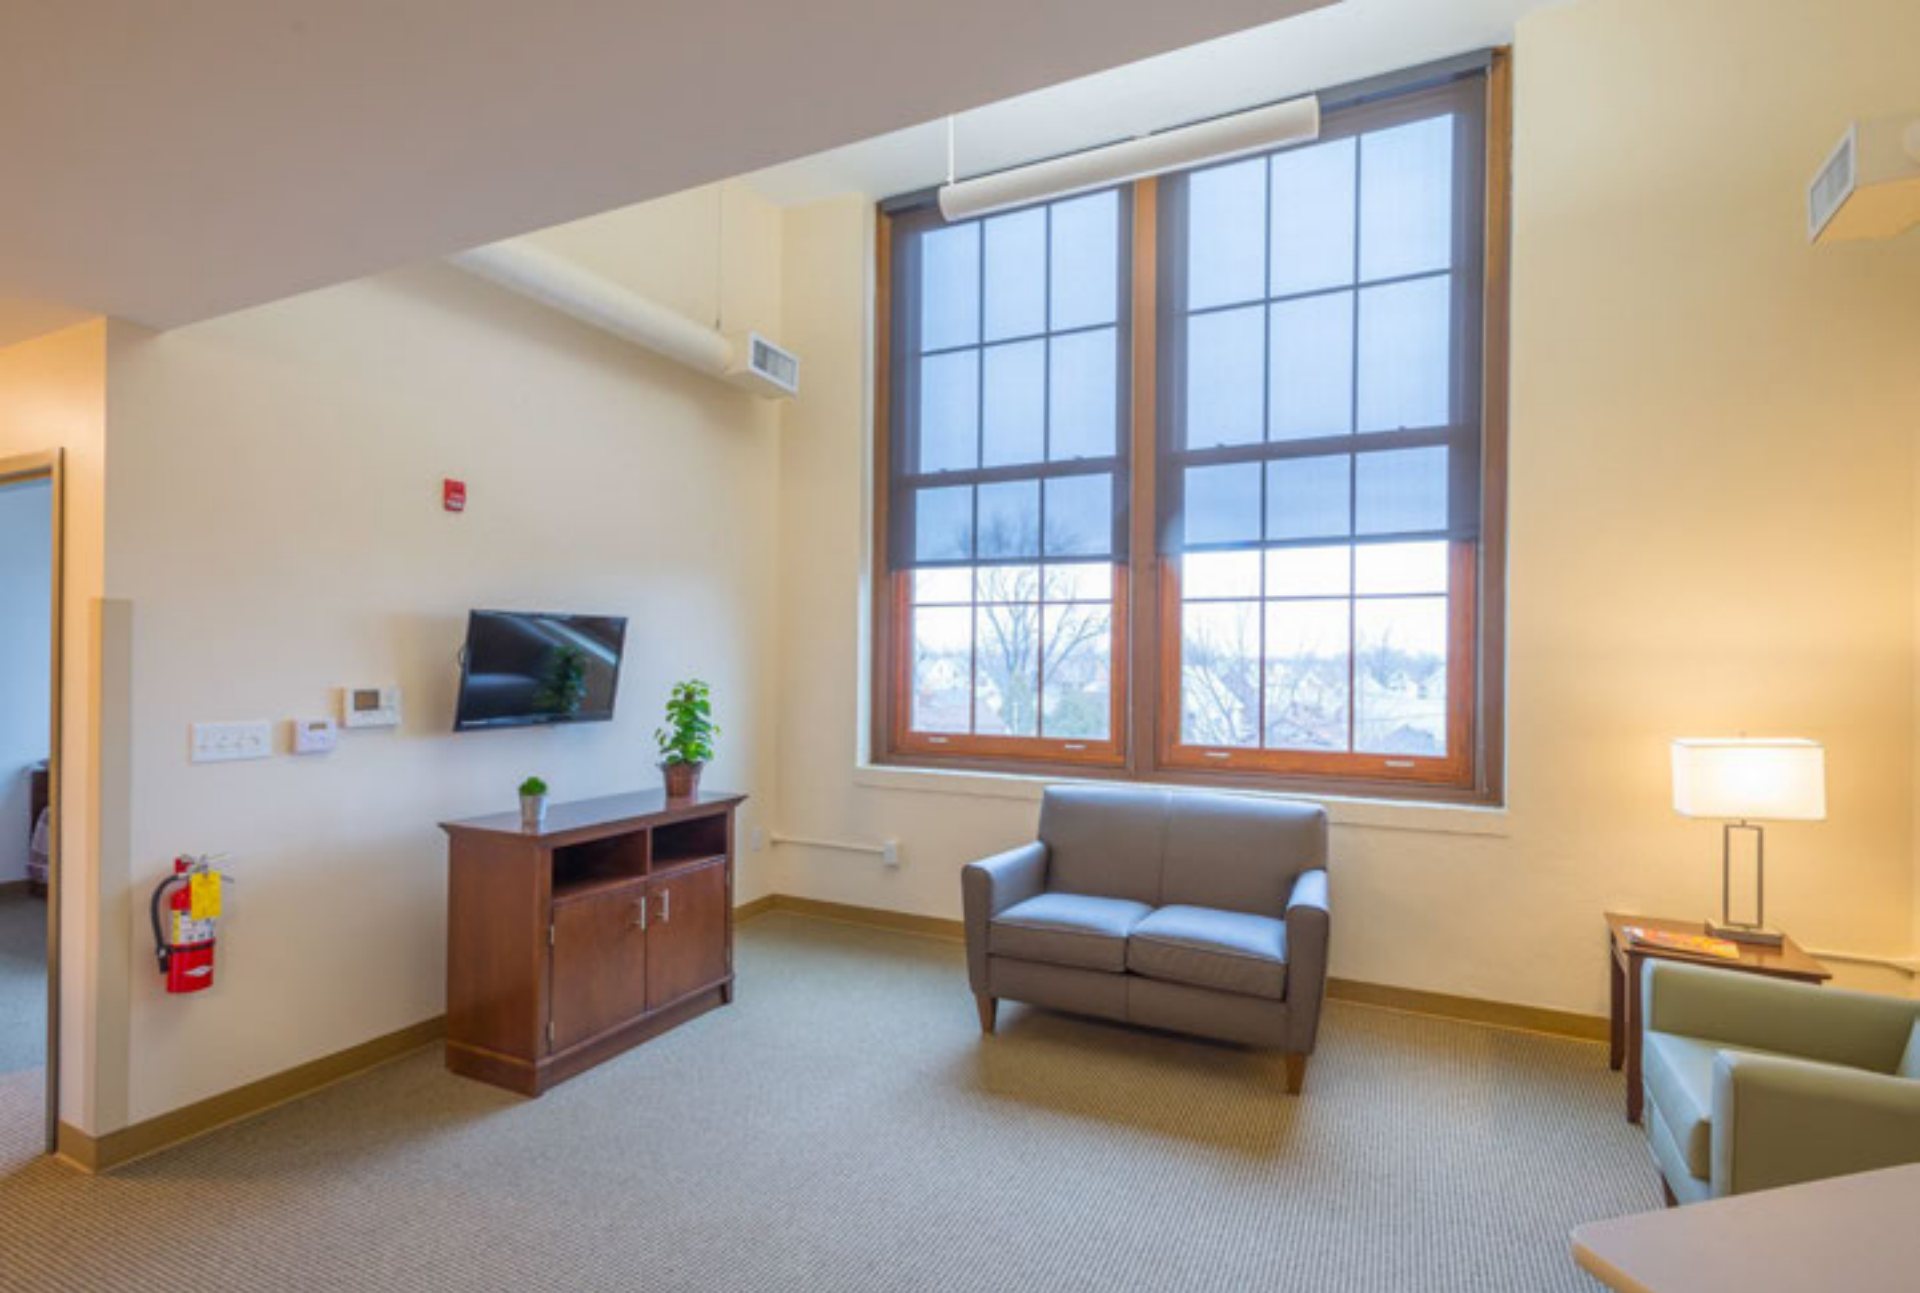
Apartment Living Area *replacement historic replica windows provide ample daylight*

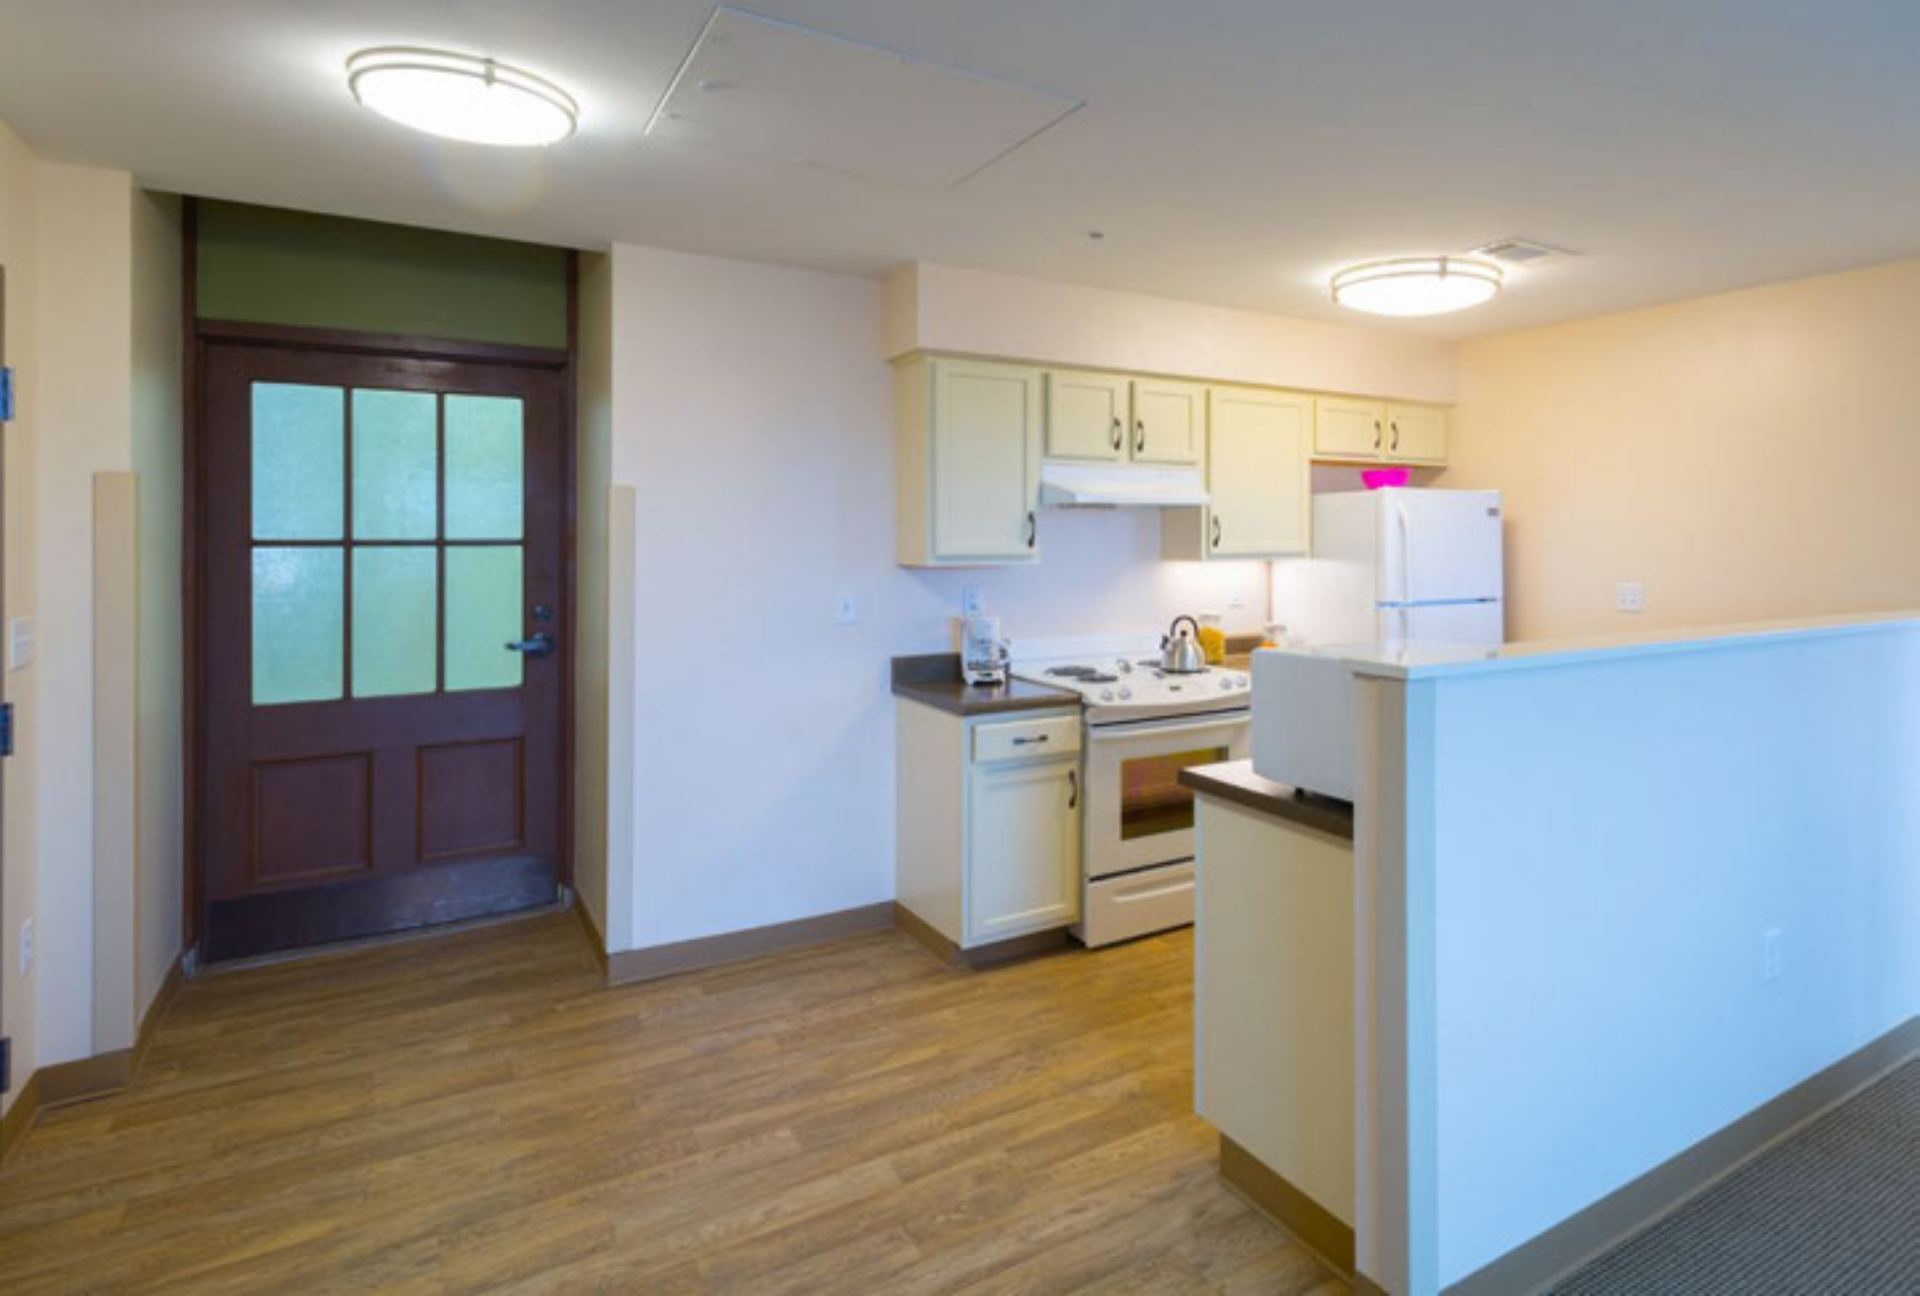
Apartment Kitchen *historic classroom doors repurposed for apartment entrances*
